Alert Service Bulletin B787-81205-SB320045-00 LANDING GEAR - Main Landing Gear - Truck Beam and Inner Cylinder Pivot Joint Inspection and Lubrication

Publication:	B787-81205-SB320045-00	Issue 001, 09 Nov 2020
--------------	------------------------	------------------------

787-8, 787-9, 787-10 Airplanes. Refer to Data Module SB B787-A-32-00-0045-00A-932A-D, Paragraph 1., Effectivity for the list of affected airplanes.

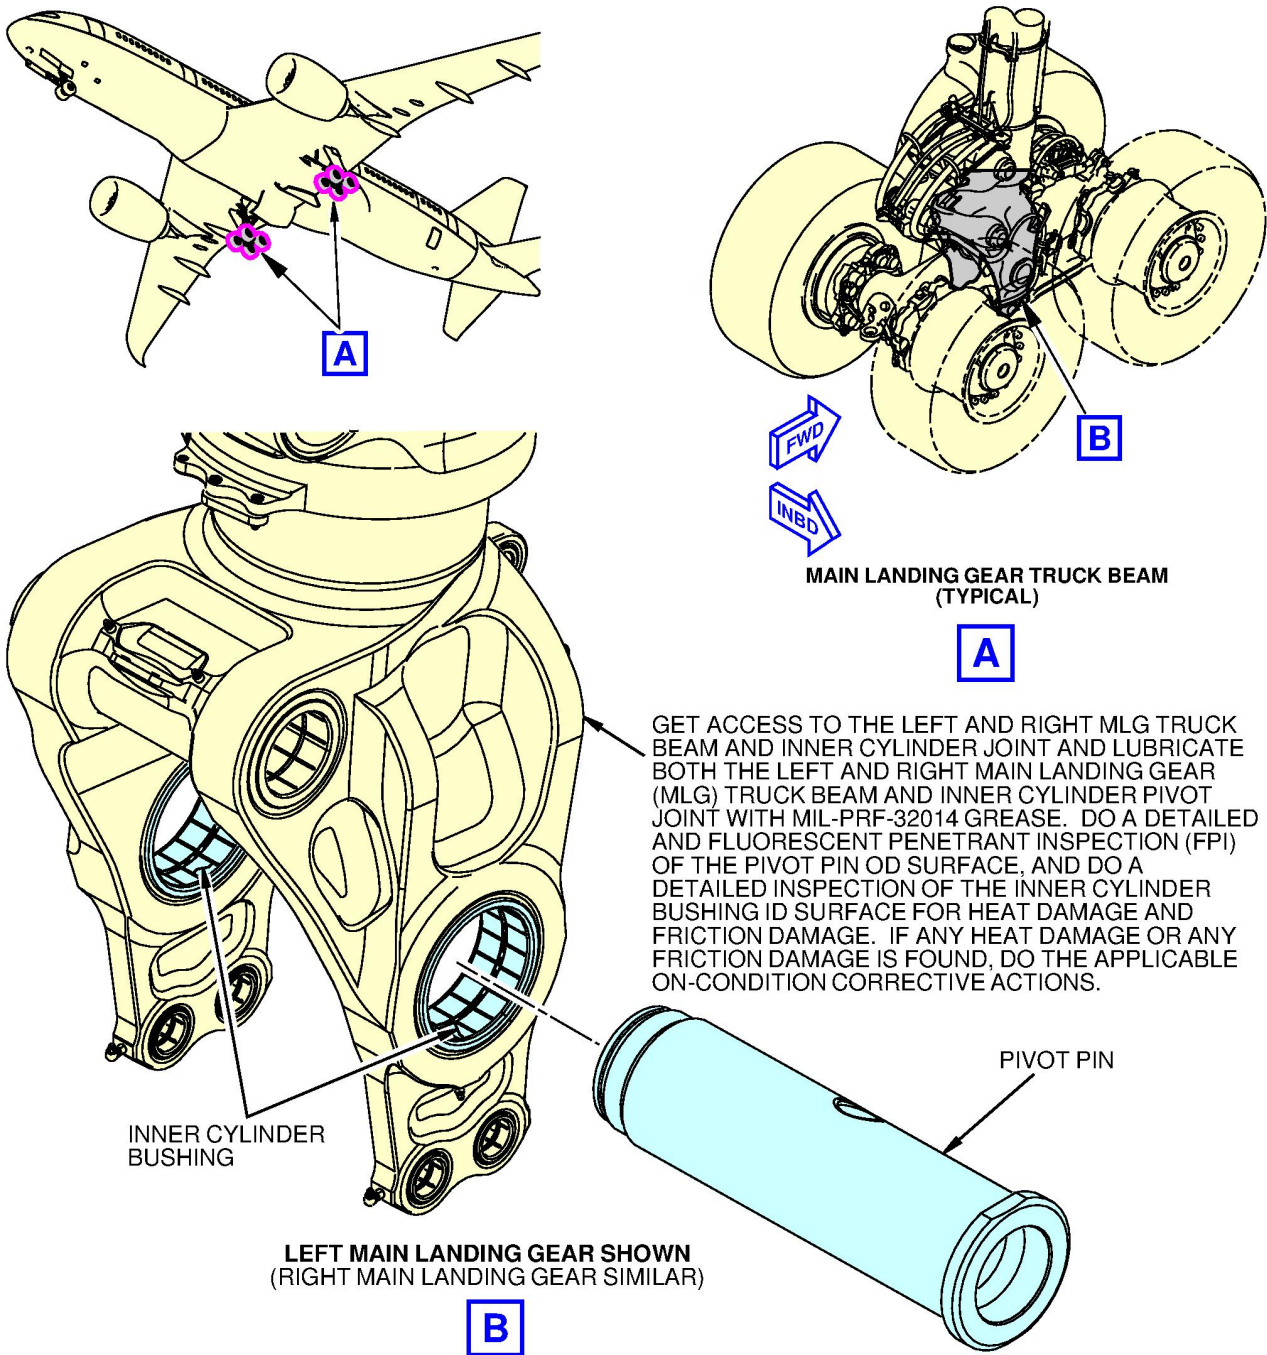
Figure 1 SUMMARY

Fleet sampling inspection of some airplanes found cracks in the left and right MLG Pivot Pins on one of the airplanes. The pins exhibited cracking of the High Velocity Oxygen Fuel (HVOF) tungsten carbide - cobalt - chrome coating. Removal of the outer diameter coating disclosed cracking of the custom 465 CRES substrate. The cause of the cracking was determined to be heat damage due to in-service friction.

This Service Bulletin gives instructions to lubricate and inspect the MLG truck beam pivot pins and inner cylinder bushings, and where necessary to repair and/or replace damaged pivot pins and bushings. The new copper-nickel-tin bushing material provides improved frictional performance.
